Pacific Power Del Norte District Transmission Audit Report

October 6-8, 2020

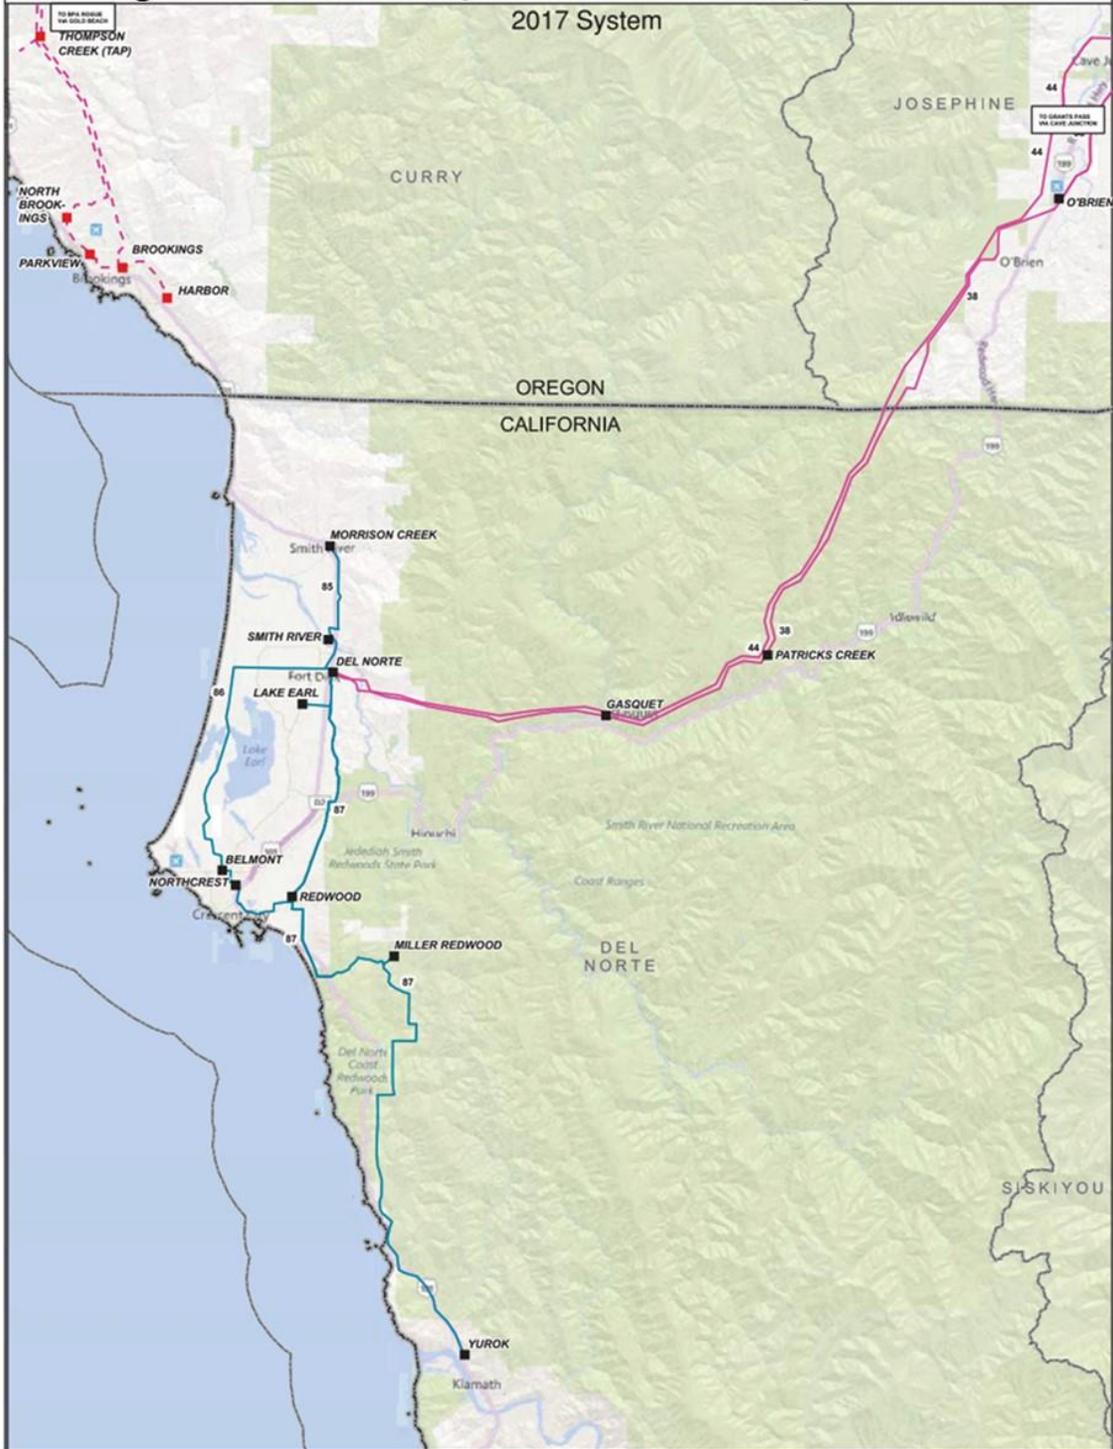
Figure 1: Crescent City Area Transmission System

Peak demand in the Crescent City Area is approximately 60 MW. To serve the Crescent City Area, Pacific Power uses two 115 kV high voltage transmission lines, Line 38 and 44, to deliver power from the Grants Pass area in southwestern Oregon to Del Norte Substation.

Del Norte Substation steps down the 115 kV voltage to 69 kV. There are three 69 kV sub-transmission lines sourced from Del Norte Substation. Line 86 and Line 87 form a loop. Line 87, besides being part of the loop, also extends south for approximately 22 miles. Line 85, a radial line sourced from Line 86, heads north for approximately 4.5 miles to the border between California and Oregon.

Please see Figure 1 for the transmission system in the Crescent City Area.
